MANAGEMENT PLAN  
UPDATE

2026

Crawford County Career and  
Technical Center  
860 Thurston Road

April 20 & 22, 2026

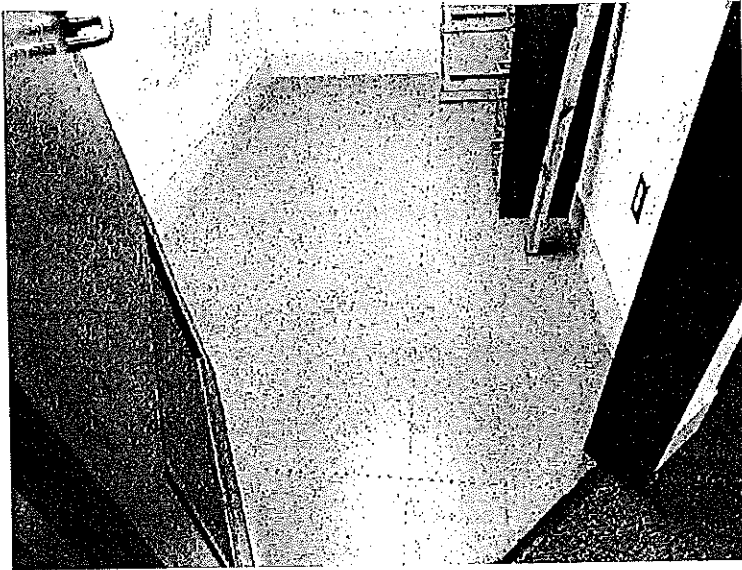
HA#: 1

Description: 9" Dark Grey Floor Tile and Mastic

Location: Electrical Operations Closet, Instructional Aide Closet, Computer & Info Science, Cafeteria

ACM: Yes

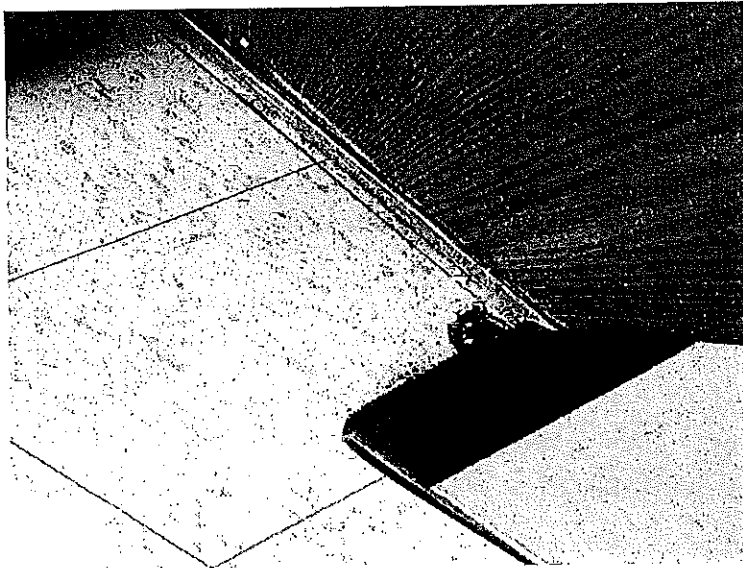
HA#: 2

Description: 9" White Speckled Floor Tile and Mastic

Location: Maintenance Room, Carpentry Teacher Office, Under Carpentry Classroom, Electronic Tech, Machining, HVAC Boy's Locker Room, 2<sup>nd</sup> Floor Office Area, Nurse's Closet

ACM: Yes

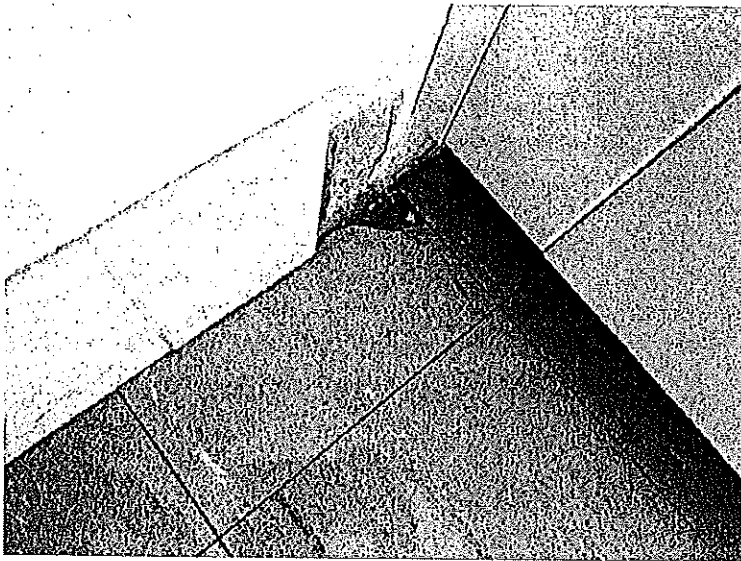
HA#: 3

Description: 9" Light Brown Floor Tile and Mastic

Location: Health Occupation Area, Weight Room

ACM: Yes

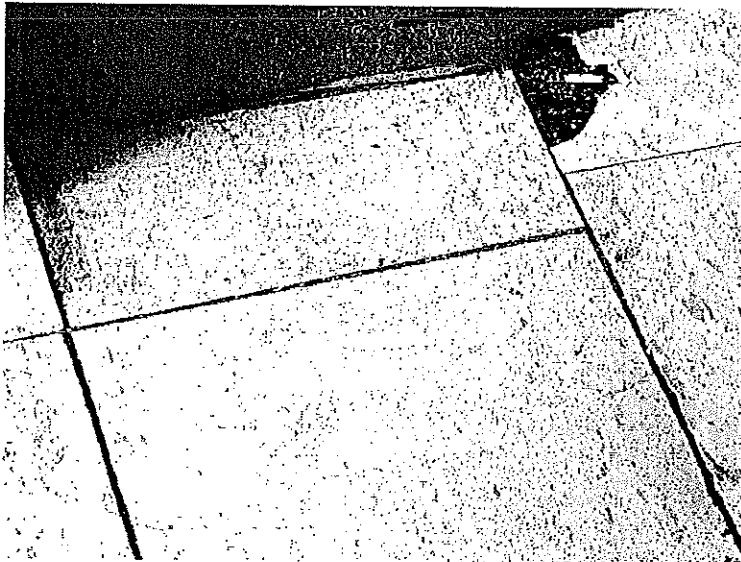
HA#: 4

Description: 9" White Streaked Floor Tile and Mastic

Location: Cosmetology

ACM: Yes

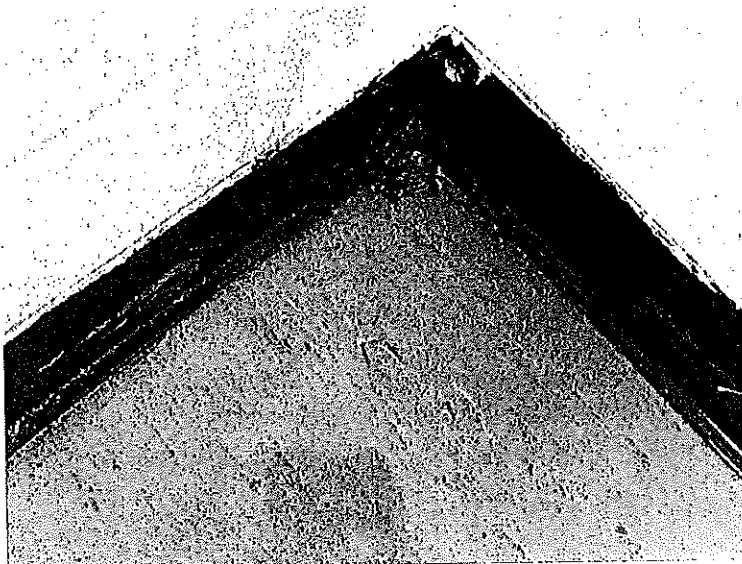
HA#: 5

Description: 9" Brown Floor Tile and Mastic

Location: Stairwell

ACM: Yes

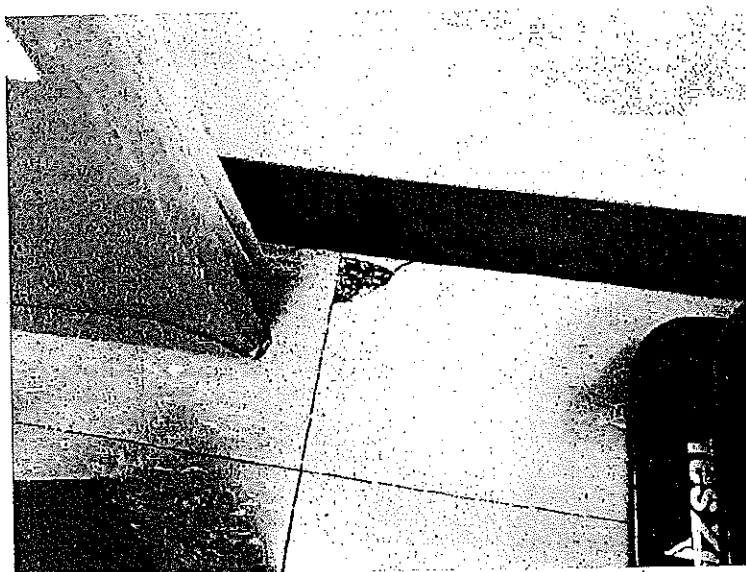
HA#: 6

Description: 12" Dark Grey Floor Tile and Mastic

Location: Welding Classroom, Welding Teacher Office, Automotive Classroom, Guidance Under Carpet, Drafting, Sports Medicine

ACM: Yes

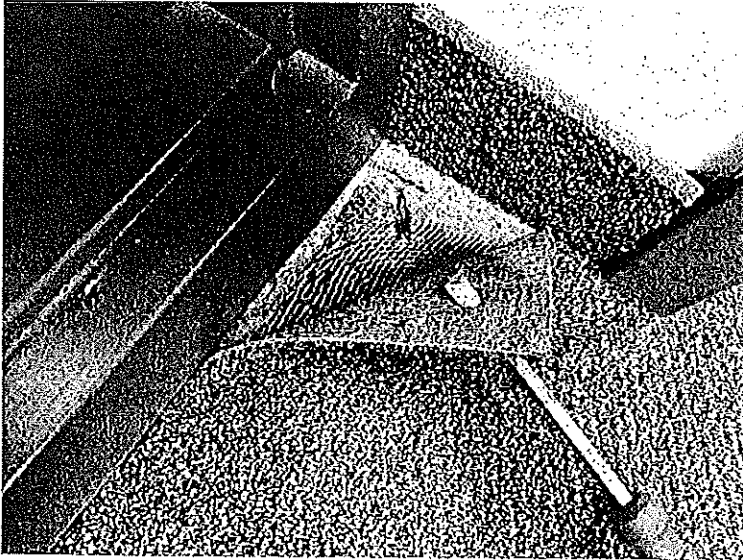
HA#: 7

Description: Residual Black Mastic

Location: Drafting / CADD, Business Manager Office, Nursing Suite

ACM: Yes

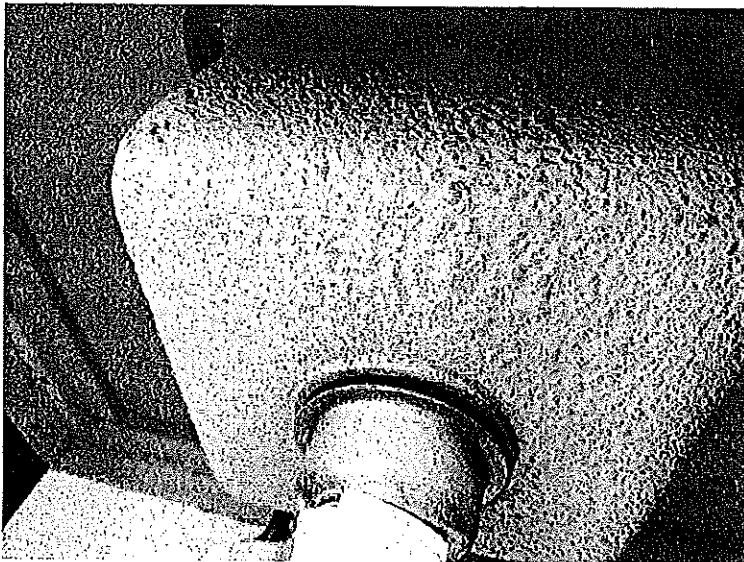
HA#: 8

Description: Sink Undercoating

Location: Child Care Services, Life Skills, Cafeteria Closet, Cosmetology, Sports Medicine, IT Storage

ACM: Yes

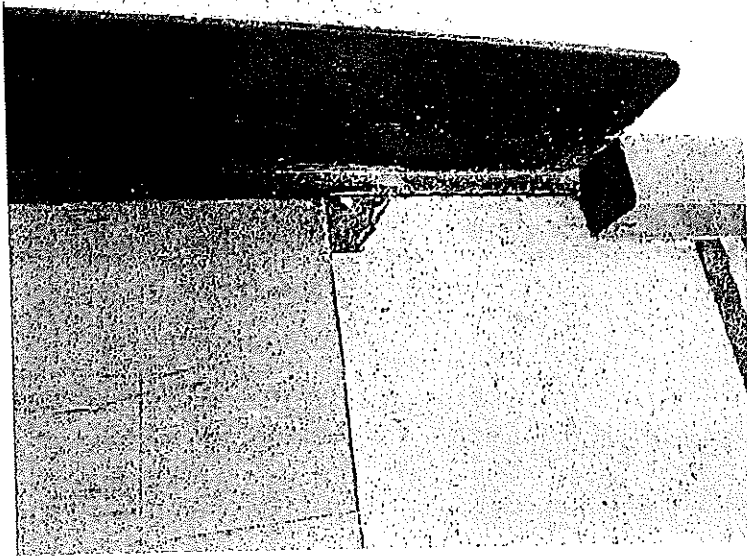
HA#: 9

Description: Stair Tread and Mastic

Location: West Stairwell

ACM: Yes

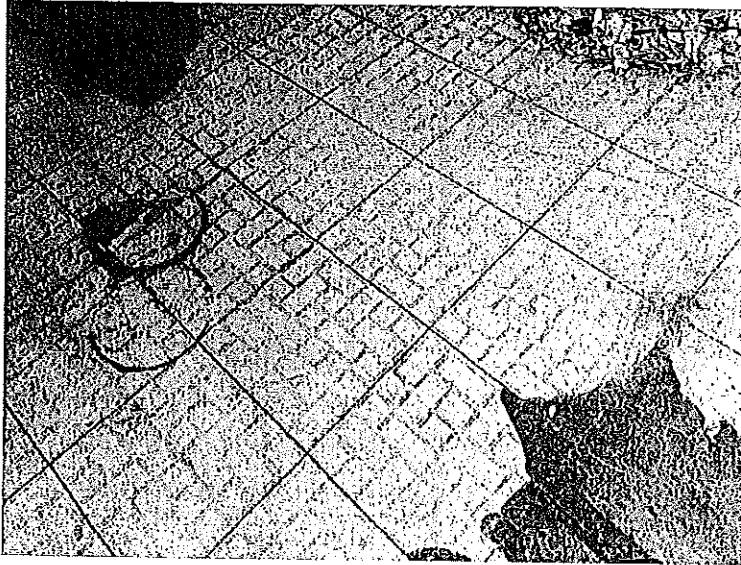
HA#: 1

Description: Floor Tile and Mastic

Location: West Side of Annex

ACM: Yes

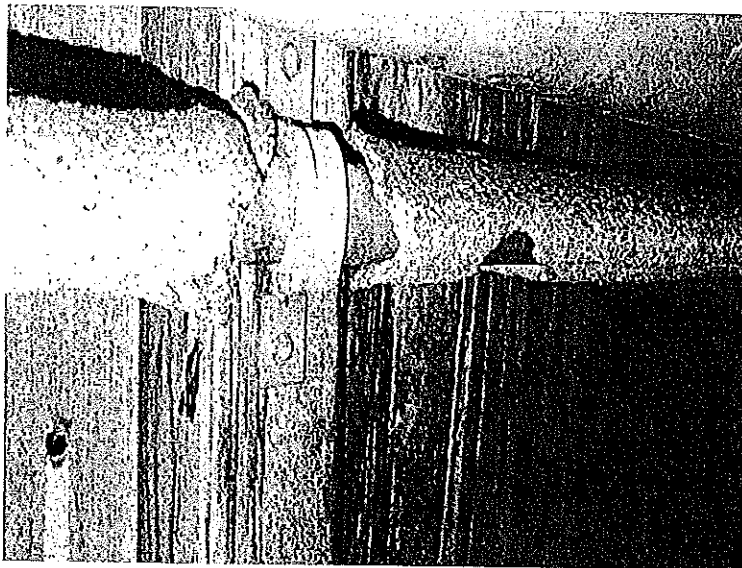
HA#: 3

Description: Pipe Insulation

Location: 2<sup>nd</sup> Floor Annex Building

ACM: Yes

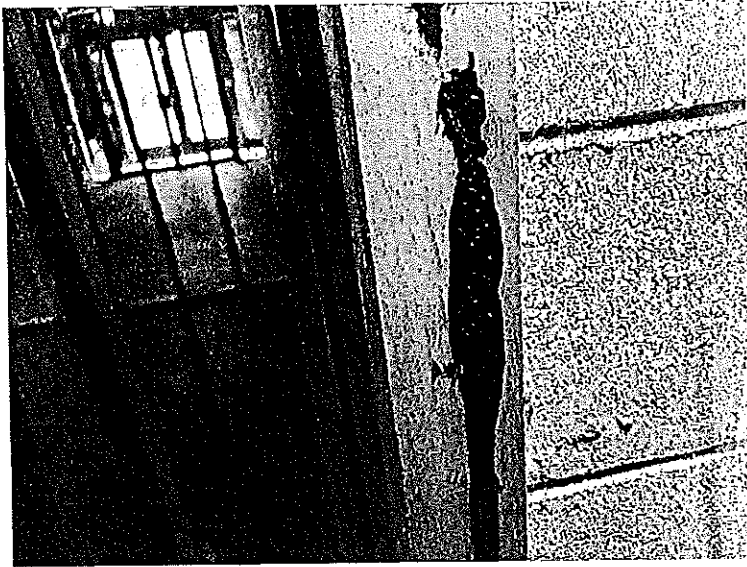
HA#: 4

Description: Residual Panel Mastic

Location: West Side of Annex Building

ACM: Yes

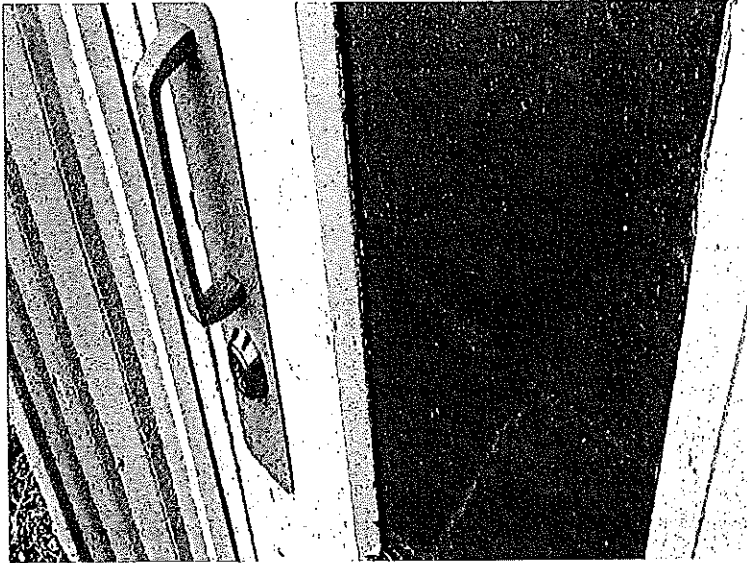
HA#: 1

Description: Exterior Door Window Glazing

Location: Storage Shed #1

ACM: Yes
